Glass Scratch Repair Kit Including 220V Bosch Grinder (Model: F.GRK.001.220)

Product Code: F.GRK.001.220

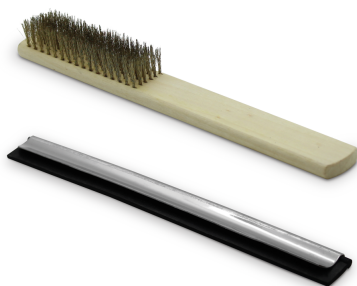
When performing a scratch repair on tempered glass, first use the Speed Adjustable Angle Grinder and the No. 1 Grinding Pad to perform a rough grind. Note that the grinding pad must be level with the glass and the speed adjusted to roughly 2500 - 3000 rpm.

When using the No. 1 Grinding Pad, you can perform the task without the need for water. Although, if using non-tempered glass, the temperature of the glass should be controlled so it does not overheat, which in turn could shatter the glass.

Once you have created a rough grind on the glass, replace the No. 1 Grinding Pad with the No. 2 Grinding Pad for a finer grind. Please note that the grinding area for the No. 2 Grinding Pad should be greater than the area for the No. 1 Grinding Pad to avoid any deformation.

In order to ensure the highest effectiveness of grinding, the glass powder on the Grinding Pad should be cleaned away periodically during the process.

5 After completion of the fine grinding, replace the No. 2 Grinding Pad with a polishing pad and proceed with polishing the glass.

6 During the polishing process, add water continuously and observe the polishing effect throughout.
